4-685-A Site Summary - Carpinteria Marsh**4-685-A****County:** Santa Barbara **ACP Division/Segment:** SB - S - S03**NOAA Chart:** 18725(a)**Map Book:** 998 A-C x 6-7**Decimal Degrees:** 34.396982 -119.537343**Site Description:**

4-685-A Site Strategy - Carpinteria Marsh

CDFW - OSPR & USCG Site: 4-685 Name: Carpinteria Marsh

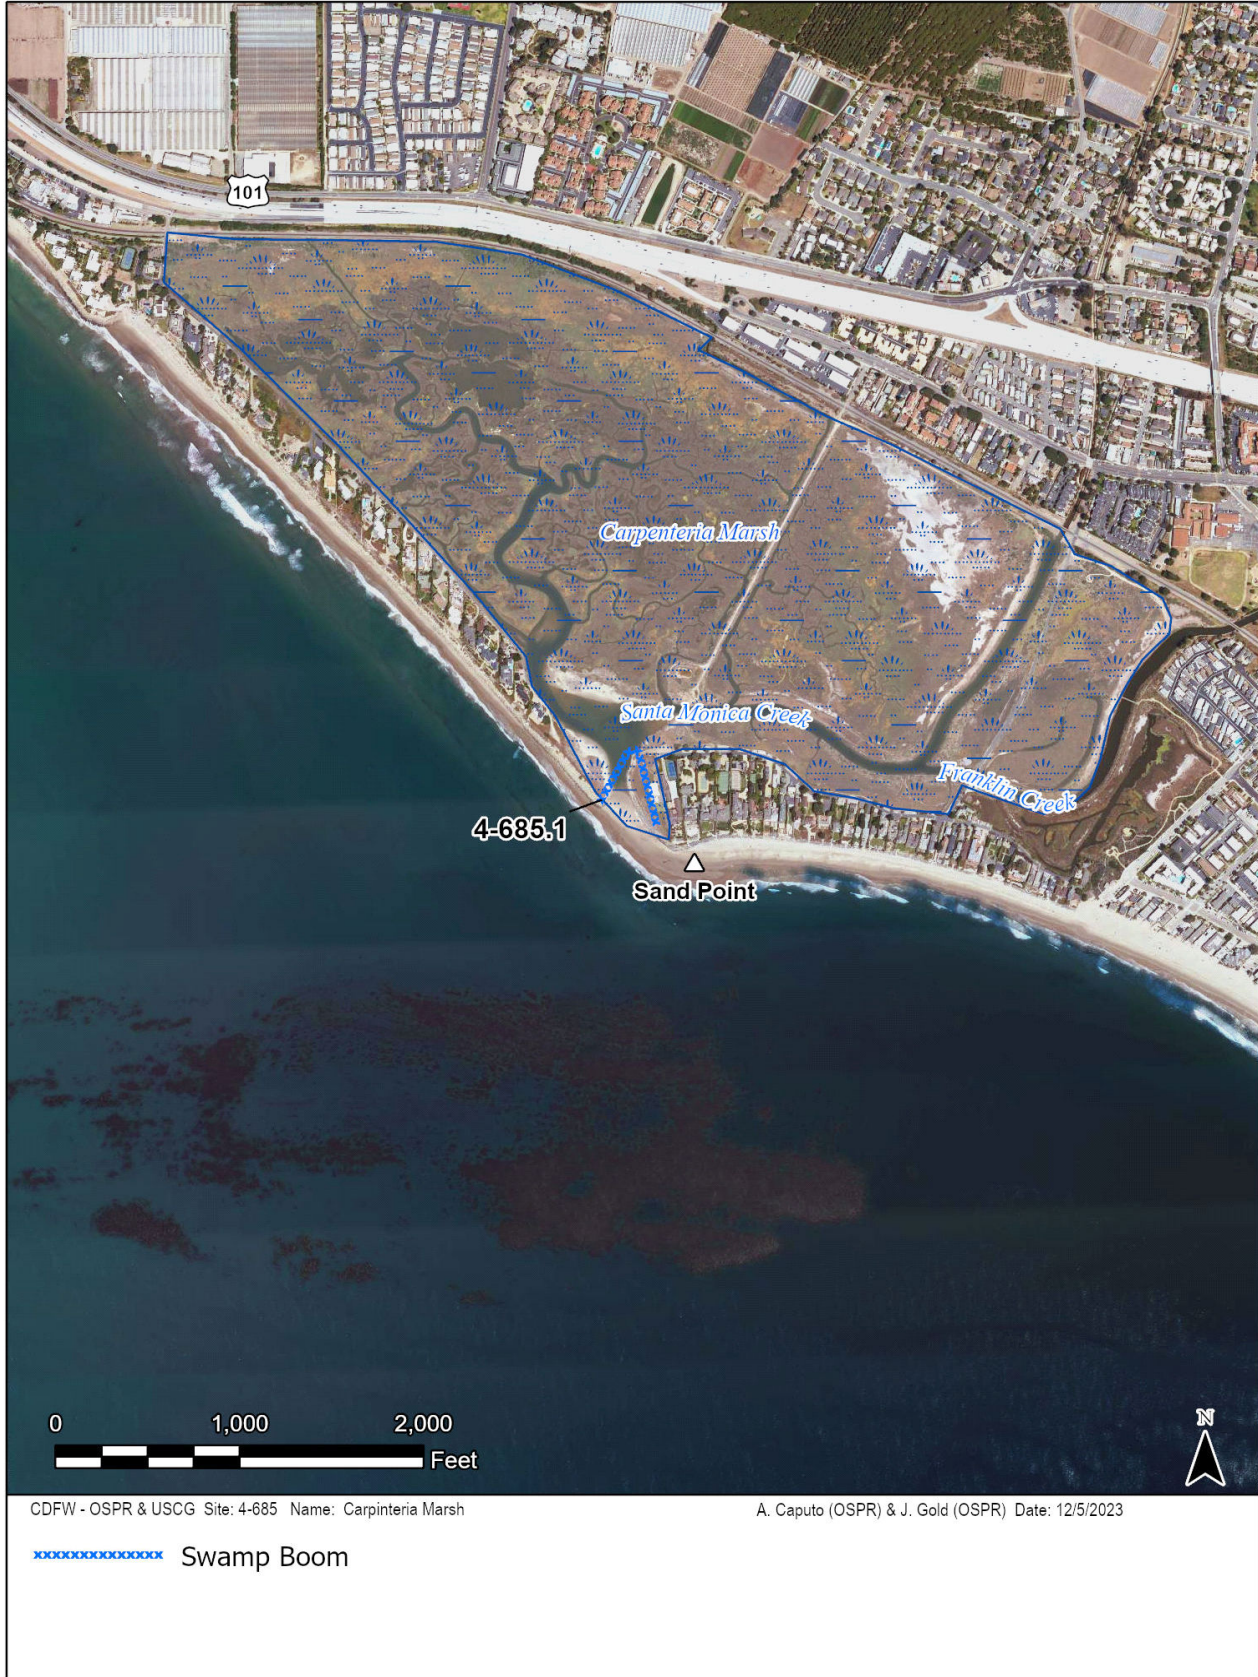
Strategy: Deploy exclusion booms across the inlet to minimize the likelihood of oiling the estuary. Place the booms in a configuration that forms an adjustable oil collection pocket that can accommodate changes in flow direction. Back exclusion booms with sorbent booms to minimize leakage. Line the shorelines and any side channels within the inlet to prevent collateral oiling. If there is recoverable oil on-water, deploy sorbents and contact the IC immediately regarding the use of skimmers. Monitor, adjust, and replace booms as needed to maintain effectiveness.

XXXXXXXXXXXX Swamp Boom
